West Branch Susquehanna Subbasin Survey

*A Water Quality and Biological Assessment,
July - November 2002*

**SUSQUEHANNA RIVER
BASIN COMMISSION**

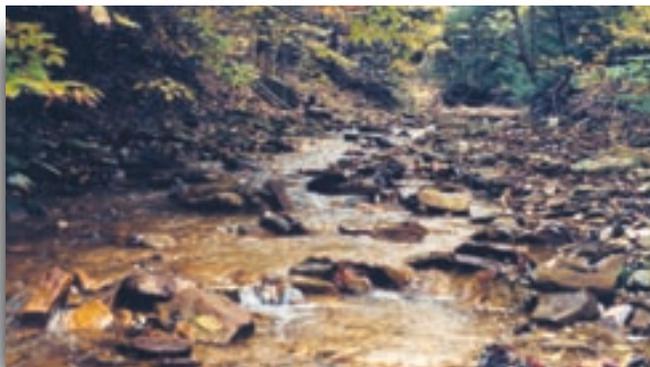
Headwaters of the West Branch Susquehanna River near Bakerton, Cambria County Impacted by Abandoned Mine Drainage (AMD)

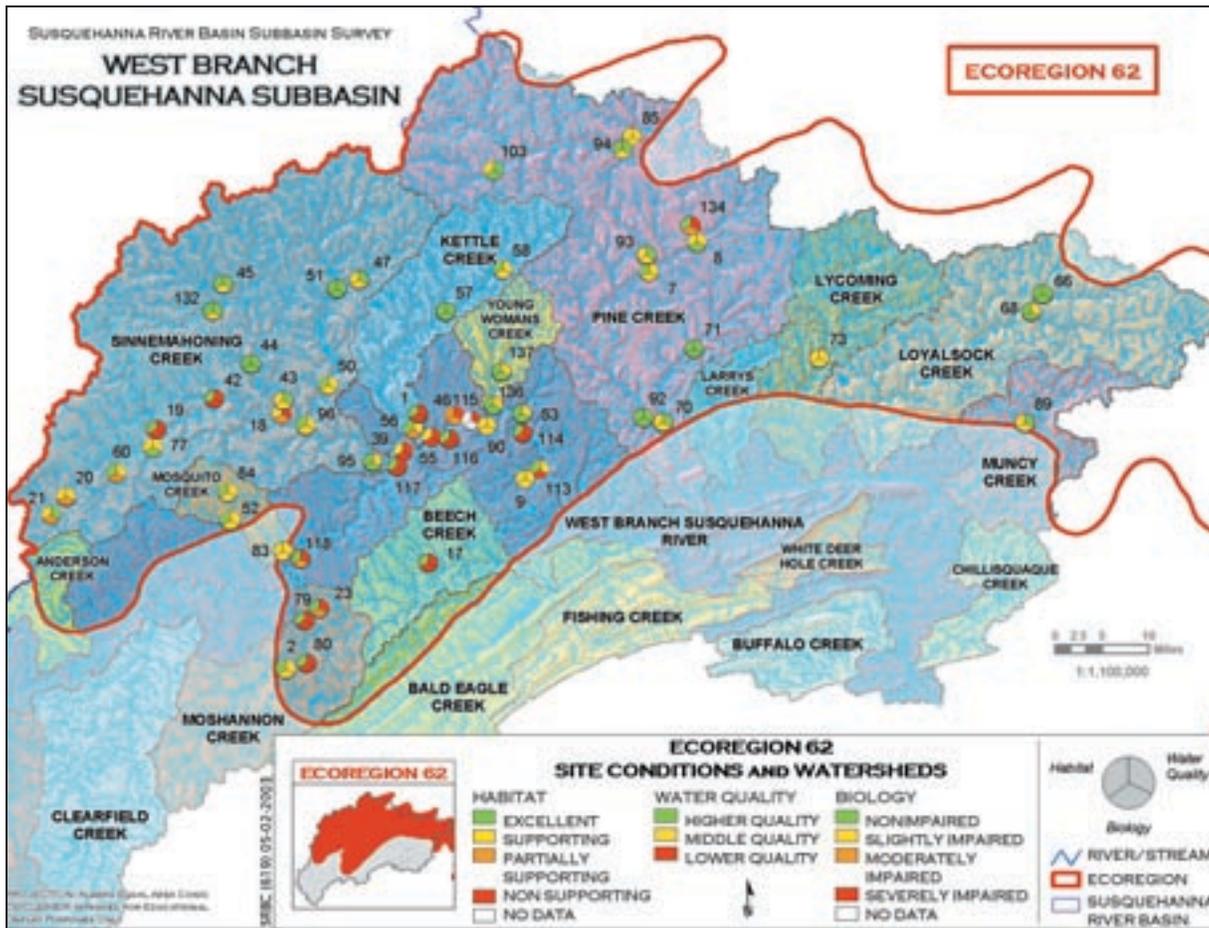
Figure 4. Water Quality, Biological, and Habitat Categories in Ecoregion 62 Sample Sites in the West Branch Susquehanna Subbasin

Figures 4 and 5 show the larger watersheds in the subbasin and their relative locations. These figures also show the ratings for water quality, biological

condition, and habitat condition of the sites in each ecoregion. Figure 6 (A, B, and C) shows a summary of the ratings for water quality, biological condition, and habitat condition in each reference category. Ecoregion 67-Small had the highest number of sites severely impacted due to water quality, biological score, and habitat; however, Ecoregion 62-Large had the largest percentage of sites impaired due to water quality and biological score. The habitat condition was rated excellent for most of the sites because a majority of the subbasin is forested. This rating is misleading for many of the streams that suffered from AMD precipitate coating the streambed. This precipitate interferes with the quality of habitat used by macroinvertebrates and was scored low for the parameters of “Epifaunal Substrate” and “Embeddedness”; however, the overall high-quality habitat of the streams outweighed these ratings. Another influence that could have affected the data in this survey was the severe drought during the summer and early fall of 2002.

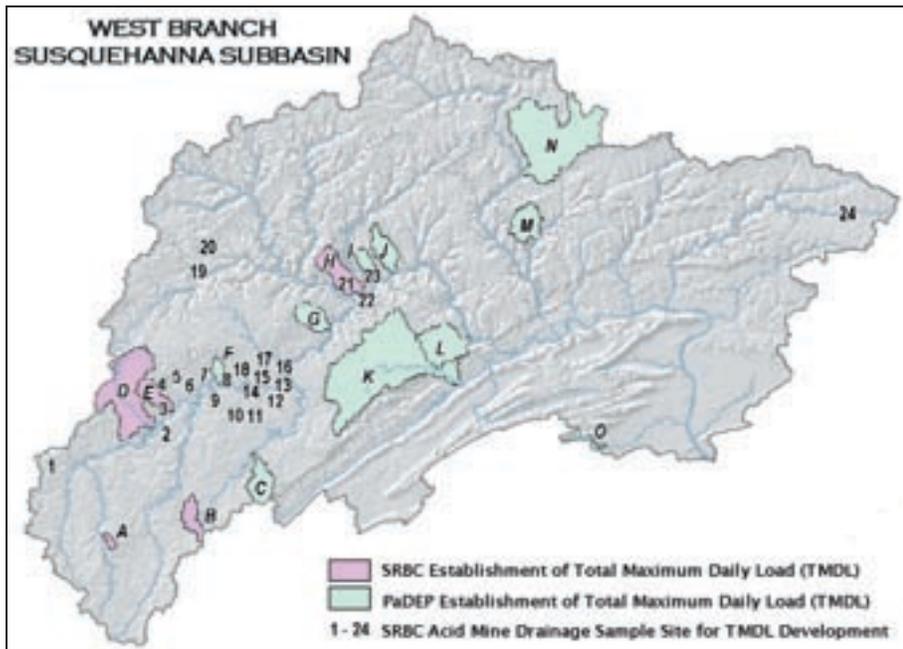
Figure 7. West Branch Susquehanna Subbasin Watersheds and Sampling Sites in the Total Maximum Daily Load (TMDL) program

impaired largely due to AMD, and subsequently, will require a TMDL. Figure 7 and Table 6 identify those watersheds that SRBC and Pa. DEP are working on as part of the TMDL program. More information on the TMDL program is available at http://www.dep.state.pa.us/watermanagement_apps/tmdl/default.asp.

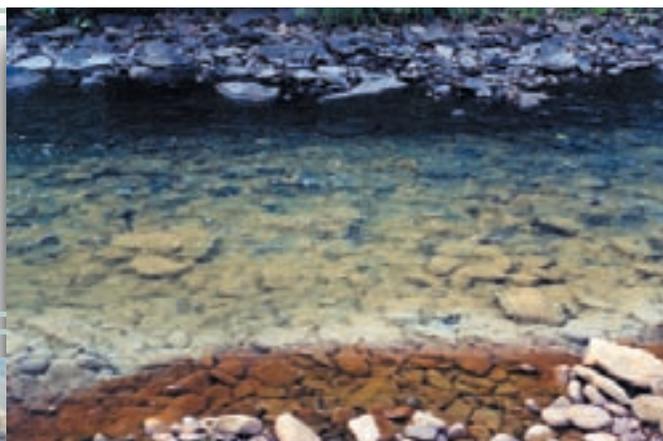
Figure 8. Tri-colored Substrate in Kettle Creek Downstream of the Two Mile Run Confluence

Two Mile Run was severely impacted by AMD. The station 2MIL 0.1 had elevated levels of metals, low pH, and low alkalinity. The water quality was rated “lower,” and the macroinvertebrate population was severely impaired. In the summer of 2001, Pa. DEP’s Bureau of Abandoned Mine Reclamation constructed a passive treatment system to treat a mine drainage seep in Two Mile Run. The system was designed

Two Mile Run that precipitated when it mixed with the higher pH stream water of Kettle Creek. The far right bank shows the unaffected conditions that characterize Kettle Creek upstream of Two Mile Run. Two Mile Run and other AMD seepages in the lower reaches impacted Kettle Creek at its mouth, where the water quality was “lower” and the macroinvertebrate population severely impaired. Low flow at the time

to treat iron, manganese, and aluminum with Successive Alkalinity Producing Systems (SAPS), a wetland, and limestone treatment beds with microorganisms that oxidize manganese. Pa. DEP plans to remediate the system, since the SAPS may be failing.

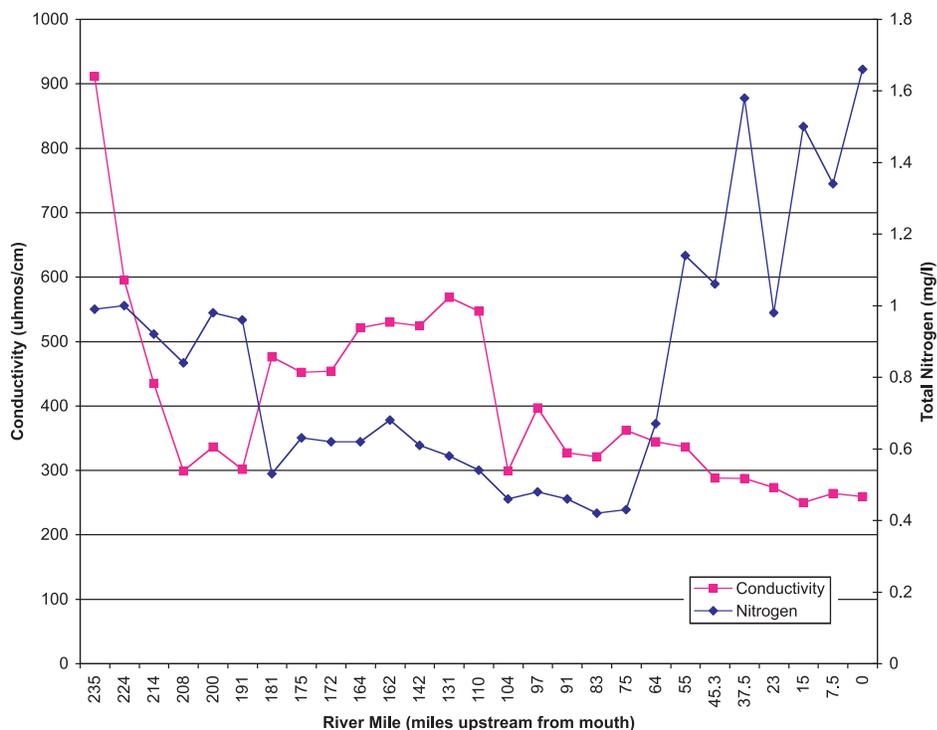
Figure 10. Nitrogen (mg/l) versus Conductivity (µhos/cm) according to River Mile

Since the West Branch Susquehanna Subbasin is mostly forestland with a few small towns, there is minimal urban influence on this subbasin. However, large portions of this watershed are degraded and lacking in biological life due to AMD. Figure 3 shows that past and current mining activities occurred mostly in the headwaters region of this subbasin. Table 4 shows sites with extreme values in parameters that are characteristic of AMD or agriculture/wastewater treatment plants. This table shows that there were numerous sites that were impacted by AMD and several sites that were impacted by nitrogen; however, no stations were clearly influenced by wastewater treatment plants. Chloride and dissolved oxygen values did not exceed the limits. Table 5 lists the same parameters that are characteristic of AMD or agriculture/wastewater treatment plants; however, it contains values for sites that have been designated as Exceptional Value (EV). Tables 4 and 5 provide comparisons of the same water quality parameters at those sites that were polluted to sites that were high quality.

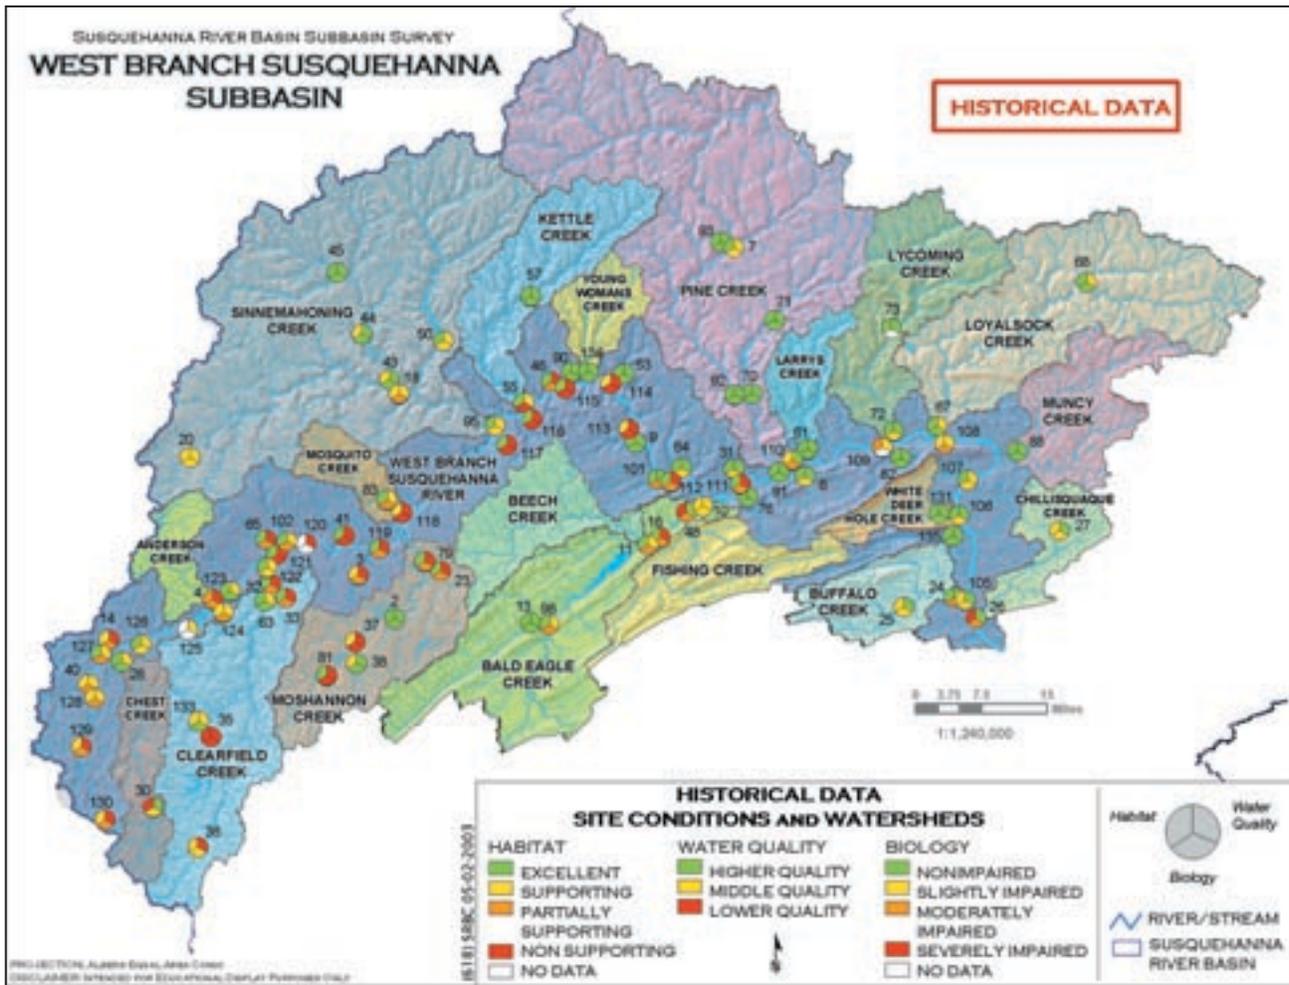
Figure 11. Water Quality, Biological, and Habitat Categories in 1994 Sample Sites in the West Branch Susquehanna Subbasin

The results for the 1994 West Branch Susquehanna Subbasin Survey are depicted in Figure 11 on the following page. These results are not directly comparable to the 2002 data since different analysis methods were used and the samples were taken at different flows; however, large differences in the categories indicate that there may have been some change. There were few drastic changes in water quality, biological condition, and habitat from 1994 to 2002, with the following exceptions: CHLLS 0.9, WBSR 162.0, WBSR 164.2, WBSR 55.0, ANDR 0.4, CLFD 42.2, DRUR 0.7, and FISH 2.1. Three of the changes were in water quality, four were in habitat condition, and one was in biological and habitat condition. At six of these eight sites, the conditions improved over the 8-year period.

Forty-three percent of the sampling sites that were historically and currently sampled were either moderately or severely impaired in 2002 compared to 47 percent in 1994. Excellent or supporting habitat was found at 91 percent of the sites in 1994 and 88 percent of the sites in 2002. This indicates there has been no major change in the overall condition of the subbasin. The West Branch Susquehanna River was impaired in the same sections in 2002, as it was in 1994. It was impaired in the headwaters and it was impaired from around Clearfield to approximately river mile 55.
