West Branch Susquehanna Subbasin Year-1 Survey

Summary Report

A Water Quality and Biological Assessment

March – July 2009

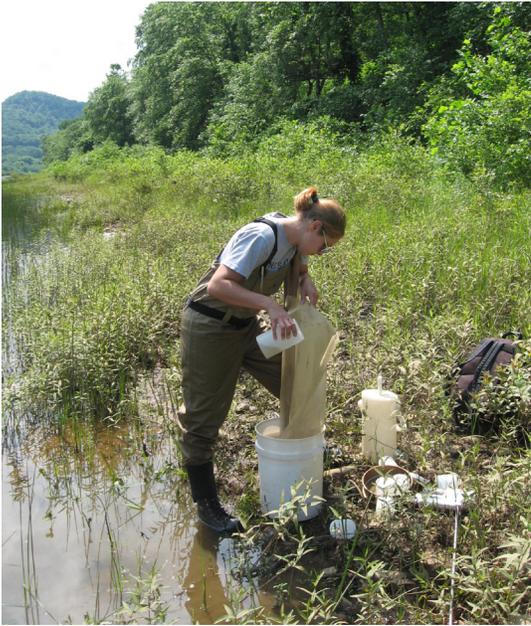
SRBC staff member processes the macroinvertebrate sample on the West Branch Susquehanna River.

Staff collected macroinvertebrate samples and conducted habitat assessments using a slightly modified version of USEPA's Rapid Bioassessment Protocols for Use in Streams and Wadeable Rivers (RBP III) (Barbour and others, 1999). Detailed sampling methods, more detailed results for individual watersheds, and a link to the raw data can be found on SRBC's web site at http://www.srbc.net/pubinfo/techdocs/publication_268/techreport268.htm.

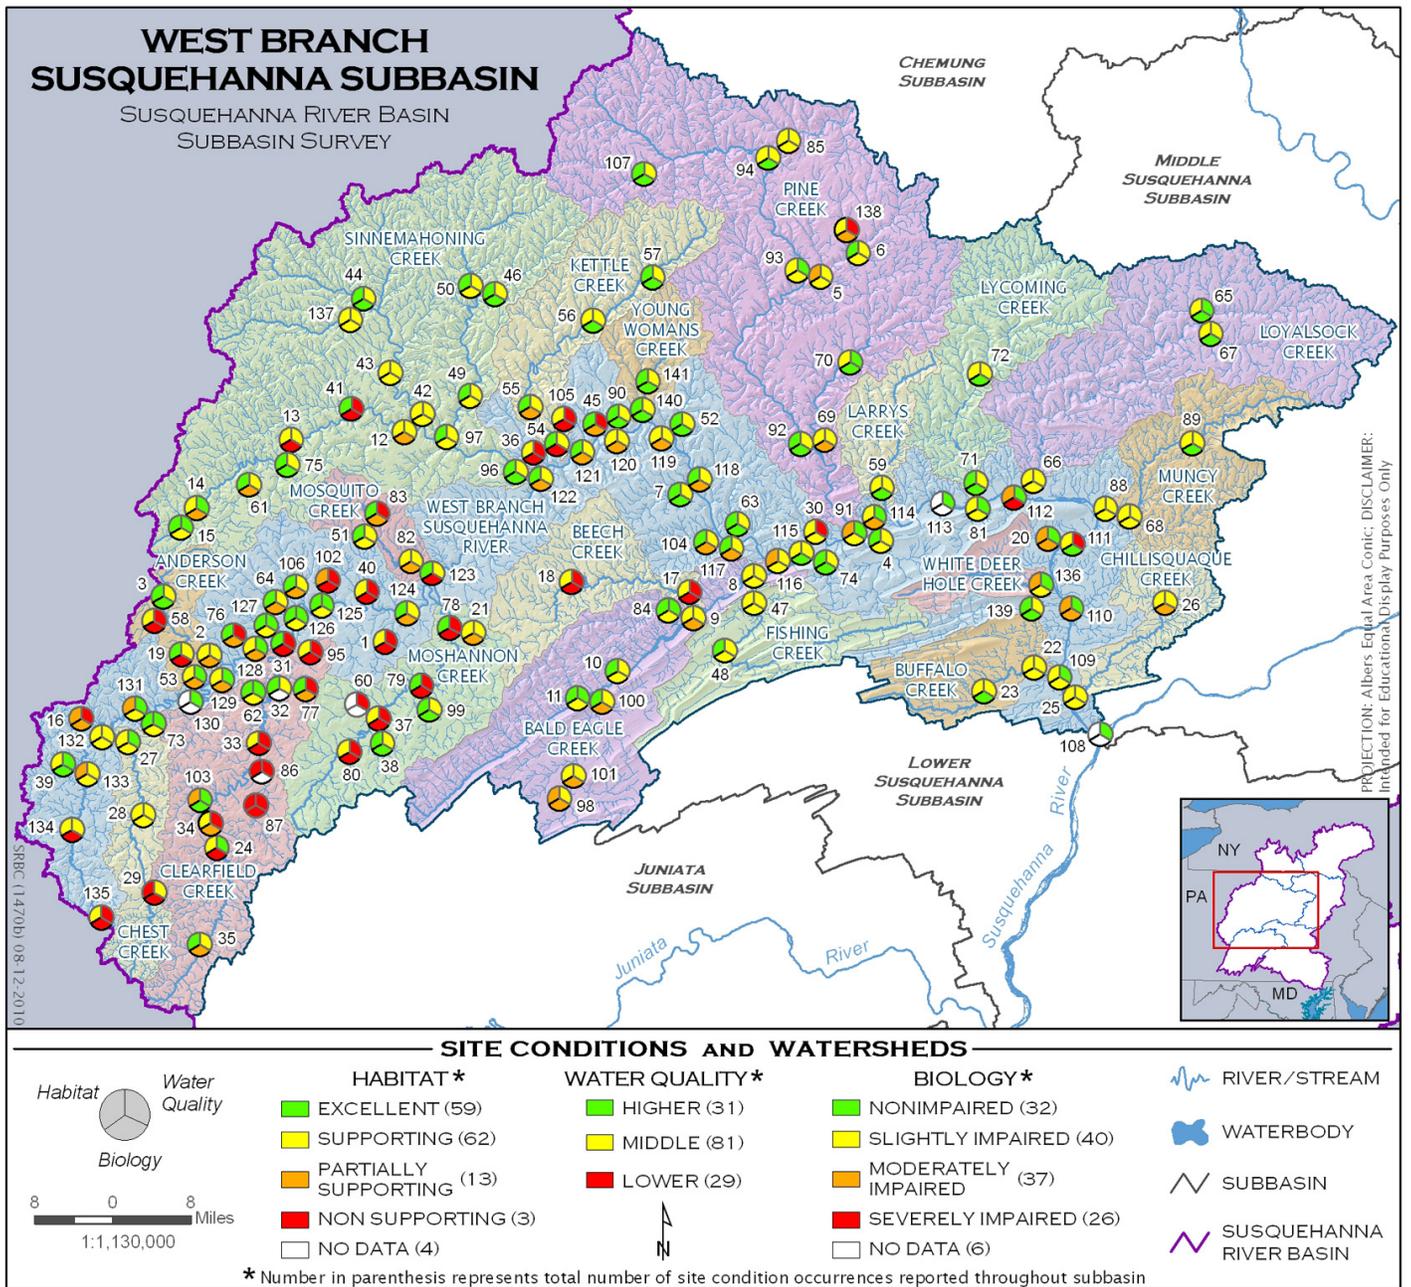
Figure 3. Water Quality, Biological, and Habitat Conditions in the West Branch Susquehanna Subbasin in 2009

Water quality, biological (macroinvertebrate) community, and habitat site conditions for each sampling site in 2009 throughout the West Branch Susquehanna Subbasin are depicted in Figure 3. Almost half of the sites (46 percent) had moderately or severely impaired biological conditions and 78 percent exceeded at least one water quality level of concern. This was largely due to AMD pollution problems in this subbasin. The habitat, however, was mostly excellent (43 percent) or supporting (46 percent) due to the remote and forested nature of a large portion of this subbasin. The best quality sites were located in the headwaters of Sinnemahoning Creek Watershed, Pine Creek Watershed, headwaters of Kettle Creek, Bucktail State Park Natural Area (from Renovo to Lock Haven, Pa.), and around Williamsport, Pa. The worst quality sites were located in the headwaters area of the West Branch Susquehanna Subbasin around Clearfield County and in Clinton County, with the largest impaired watershed areas being Clearfield Creek and Moshannon Creek.

Thirty-one sites had the highest water quality rating (higher quality), 32 sites scored the highest biological rating (nonimpaired), and 59 sites had the highest habitat rating (excellent); however, there were no sites that had the highest level of conditions for all three categories. Nineteen of the sites that had nonimpaired biological conditions and excellent habitat had middle water quality due to exceeding alkalinity standards. In fact, alkalinity was the parameter that exceeded levels of concern at the highest number of sites (78) (Table

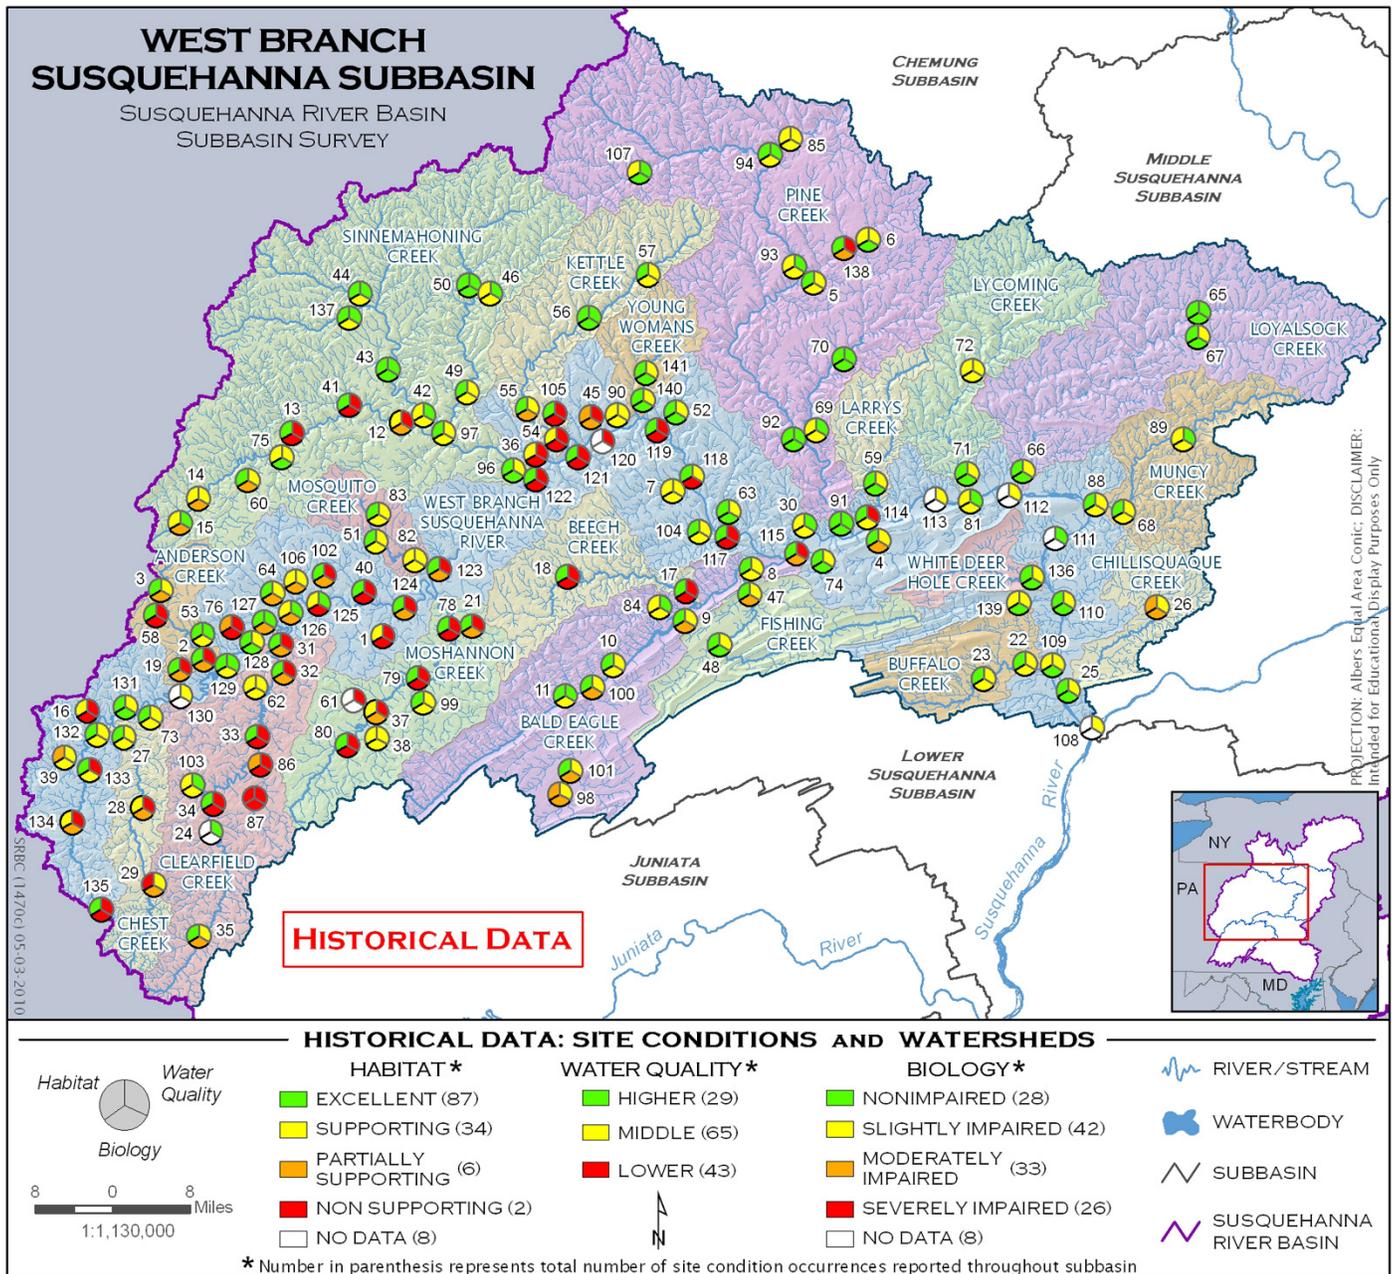
Figure 4. Water Quality, Biological, and Habitat Conditions in the West Branch Susquehanna Subbasin in 2002

Biological, water quality, and habitat conditions from the subbasin survey in 2002 (LeFevre, 2003) are depicted in Figure 4. The distribution of conditions was similar to that in 2009 (Figure 3) with the red colors (severely impaired, “lower”, and nonsupporting conditions) located in the abandoned mine land areas in the western portion of the subbasin and the green colors (nonimpaired, “higher”, and excellent) located in the northern and eastern portions of the subbasin. The watersheds that were higher quality and reference watersheds in 2002 continued to be higher quality in 2009. Some individual watersheds showed improvement, such as Babb Creek, Cush Creek, and Sinnemahoning Creek, and many sites on the West Branch Susquehanna River mainstem showed marked improvement from 2002 to 2009.

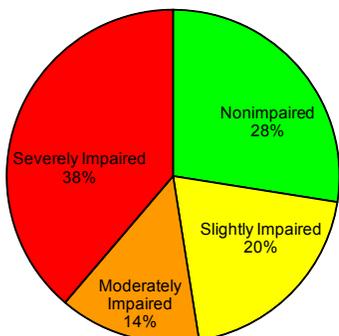
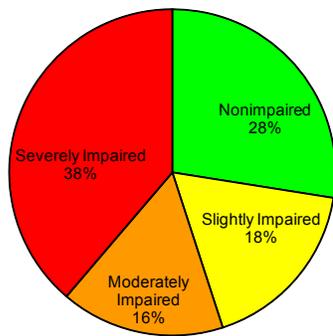
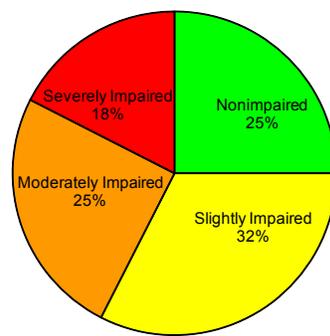
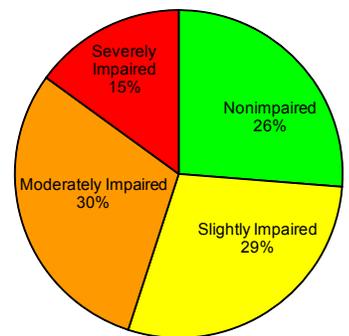
Figure 5. 1983 Biological Conditions

Figure 6. 1994 Biological Conditions

Figure 7. 2002 Biological Conditions

Figure 8. 2009 Biological Conditions

Figures 5–8 show the percentage of biological condition categories in the different subbasin surveys in 1983, 1994, 2002, and 2009 for the sites that were sampled in all four surveys. These pie charts indicate that biological condition has improved from 1983 to 2009. The percentage of severely impaired stream sites has decreased from 38 percent in 1983 and 1994 to 18 and 15 percent in 2002 and 2009, respectively. The percentage of moderately and severely impaired sites has decreased from 52 percent and 54 percent in 1983 and 1994, respectively, to 43 percent and 45 percent in 2002 and 2009, respectively.

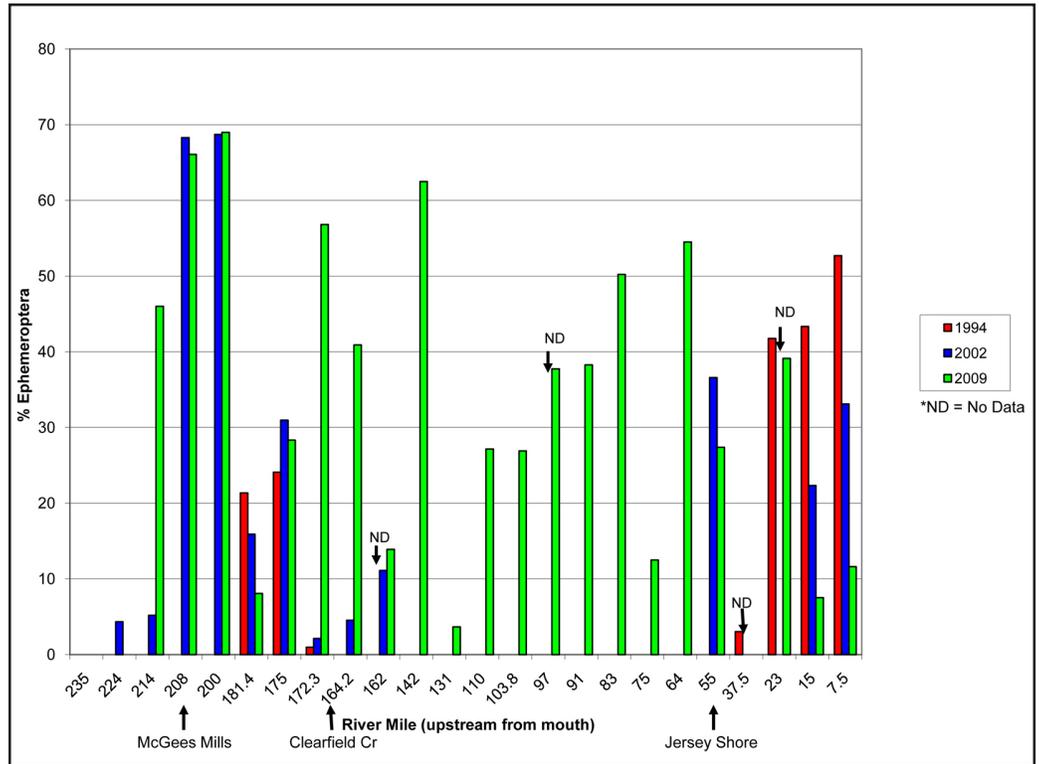
Figure 9. Percent Ephemeroptera at Mainstem Susquehanna River Sites during 1994, 2002, and 2009

Figure 9 shows percent Ephemeroptera at the sites on the mainstem river (in river miles upstream from mouth) in 1994, 2002, and 2009. Arrows and letters “ND” indicate that no data were taken during that year. All other places without a bar line indicate that no mayflies were found at that site. The percentage of mayflies inhabiting the mainstem river improved mostly between the 2002 and 2009 surveys. The stretch of river from WBSR 172.3 (just upstream of Clearfield Creek in Clearfield) to WBSR 64 (just upstream of Jersey Shore) had large increases in percent mayflies in 2009. Many of the sites did not have mayflies in the 1994 and 2002 samples. The highest percentage of mayflies was found at the sites around McGees Mills. These sites had almost 70 percent Ephemeroptera. Some of the sites downstream of Jersey Shore had decreases in the percent Ephemeroptera metric in 2009. This may be due to sediment embedding the substrate and impacting macroinvertebrate habitat.

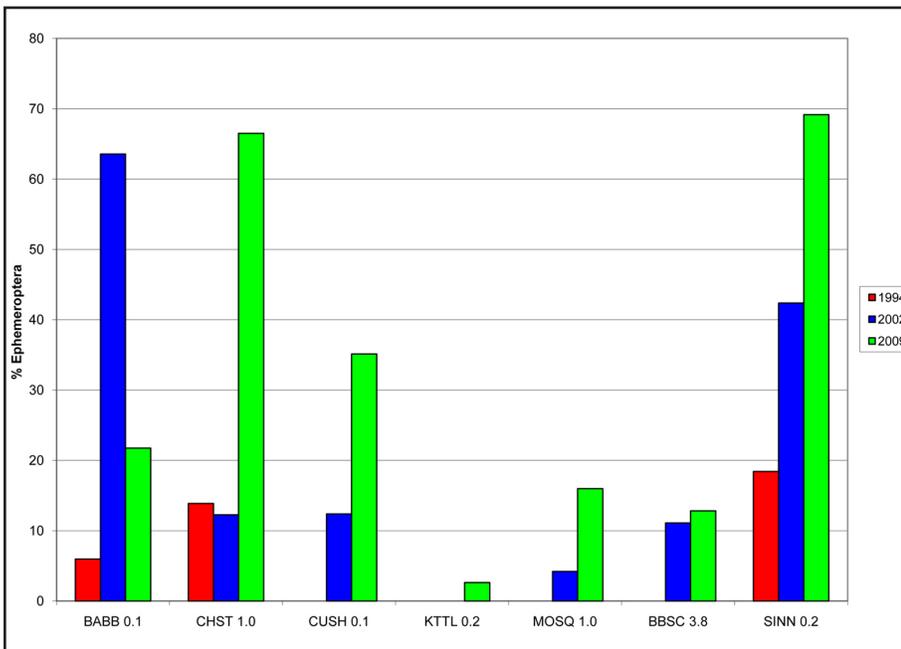
Figure 10. Sample Sites Showing Increased Percent Ephemeroptera Indicating Improved AMD Conditions

Tributary watersheds that had increases of percent Ephemeroptera indicating improvements in AMD condition were Babb Creek, Chest Creek, Cush Creek, Kettle Creek, Mosquito Creek, Bennett Branch Sinnemahoning Creek, and Sinnemahoning Creek (Figure 10). Babb Creek had a large increase in mayflies in 2002 and a decrease in 2009, although the percentage of mayflies is larger than 20 percent (higher than 25 percent mayflies in the sample indicates healthy conditions). Remediation of Babb Creek began in 1990. In 2009, 14 miles of Babb Creek were removed from the 303(d) list of impaired waters. Chest Creek, Cush Creek, and Sinnemahoning Creek showed significant improvement throughout the years and all have percent Ephemeroptera values higher than 25 percent. Kettle Creek, Mosquito Creek, and Bennett Branch Sinnemahoning Creek appear to have started improving, but need additional restoration.

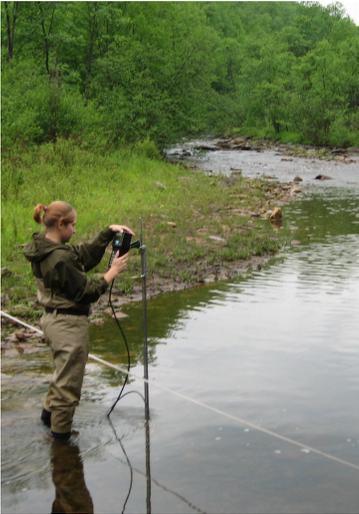
SRBC staff member measures flow along Mosquito Creek, one of the seven tributaries showing improvements in AMD condition.

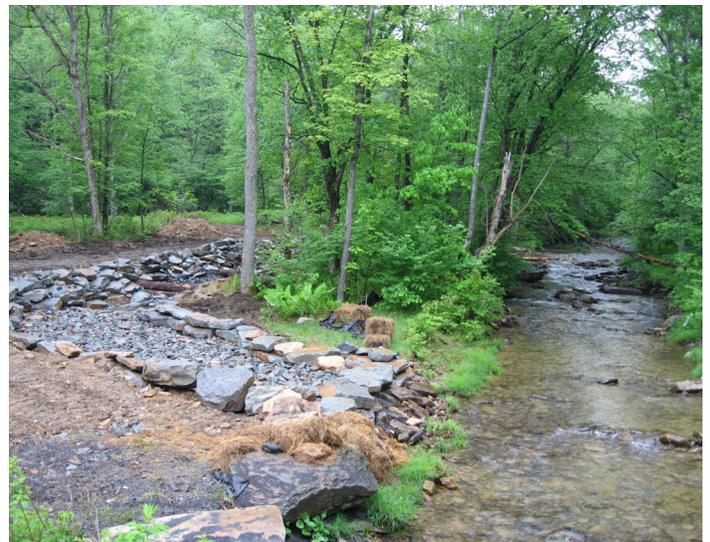
Acidic Deposition Treatment System on Gifford Run north of Karthaus, Pa.
