2013-2014 LARGE RIVER ASSESSMENT PROJECT

Publication No. 302

September 30, 2015

*Monitoring and Protection Program
Susquehanna River Basin Commission*

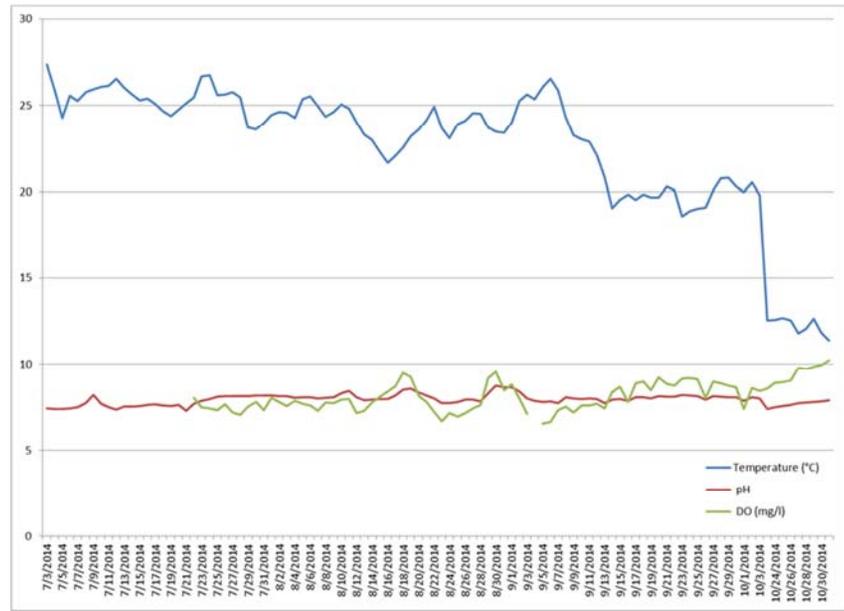
Figure A4d. 2014 Continuous Temperature, pH, and Dissolved Oxygen (DO) Data near SUSQ138

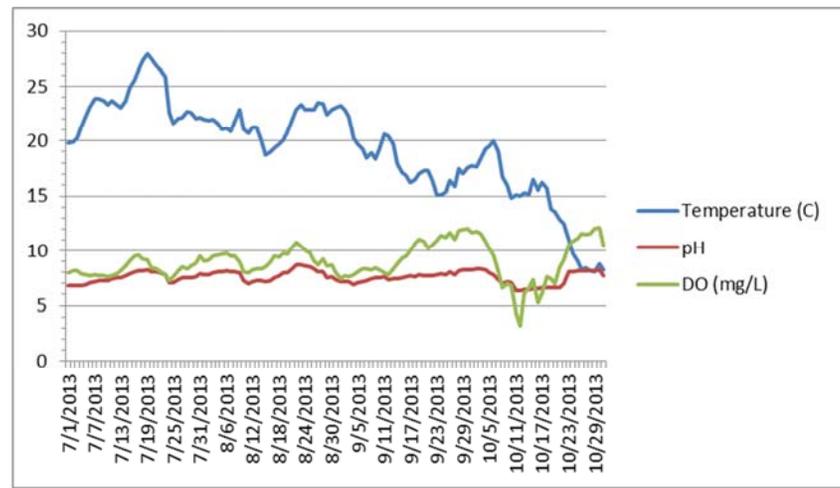
Figure A5b. 2013 Continuous Temperature, pH, and Dissolved Oxygen (DO) Data near SUSQ356

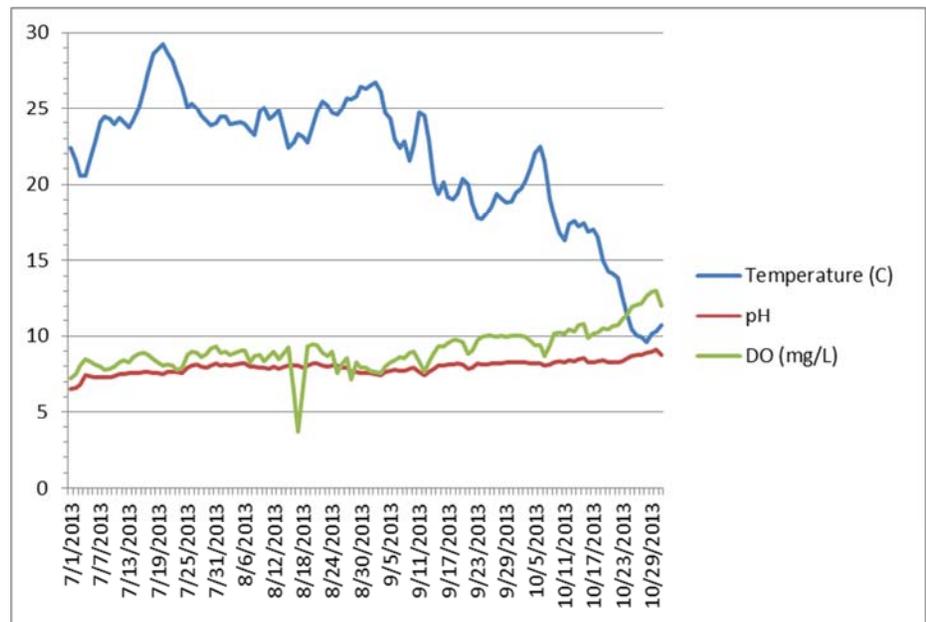
Figure A7b. 2013 Continuous Temperature, pH, and Dissolved Oxygen (DO) Data near WBSR5
