## Total Phosphorus (TP) and Nitrate (NO<sub>3</sub>-N) Discrete Sampling at Continuous Instream Monitoring (CIM) Stations in Upper and Chemung Subbasins

The Susquehanna River Basin Commission (Commission) launched the [Continuous Instream Monitoring \(CIM\)](#) (formerly known as the Remote Water Quality Monitoring Network/RWQMN) in 2010 to measure water quality indicators across the Susquehanna River Basin. Over 65 historic and active CIM stations exist basinwide, with 23 in the Upper and Chemung Subbasins. Water quality parameter data are measured and transmitted every 15 minutes at these stations. **Trends** in water chemistry data (temperature, dissolved oxygen, pH, turbidity, and specific conductivity) at sites with more than 10 years of data can be explored on the [CIM StoryMap](#) and [CIM Dashboard](#). Additional sampling occurs each year including **discrete water sampling for nutrients and metals, macroinvertebrate surveys, fish surveys, and streamflow measurements**. These data are available upon request ([cim@srbc.gov](mailto:cim@srbc.gov)).

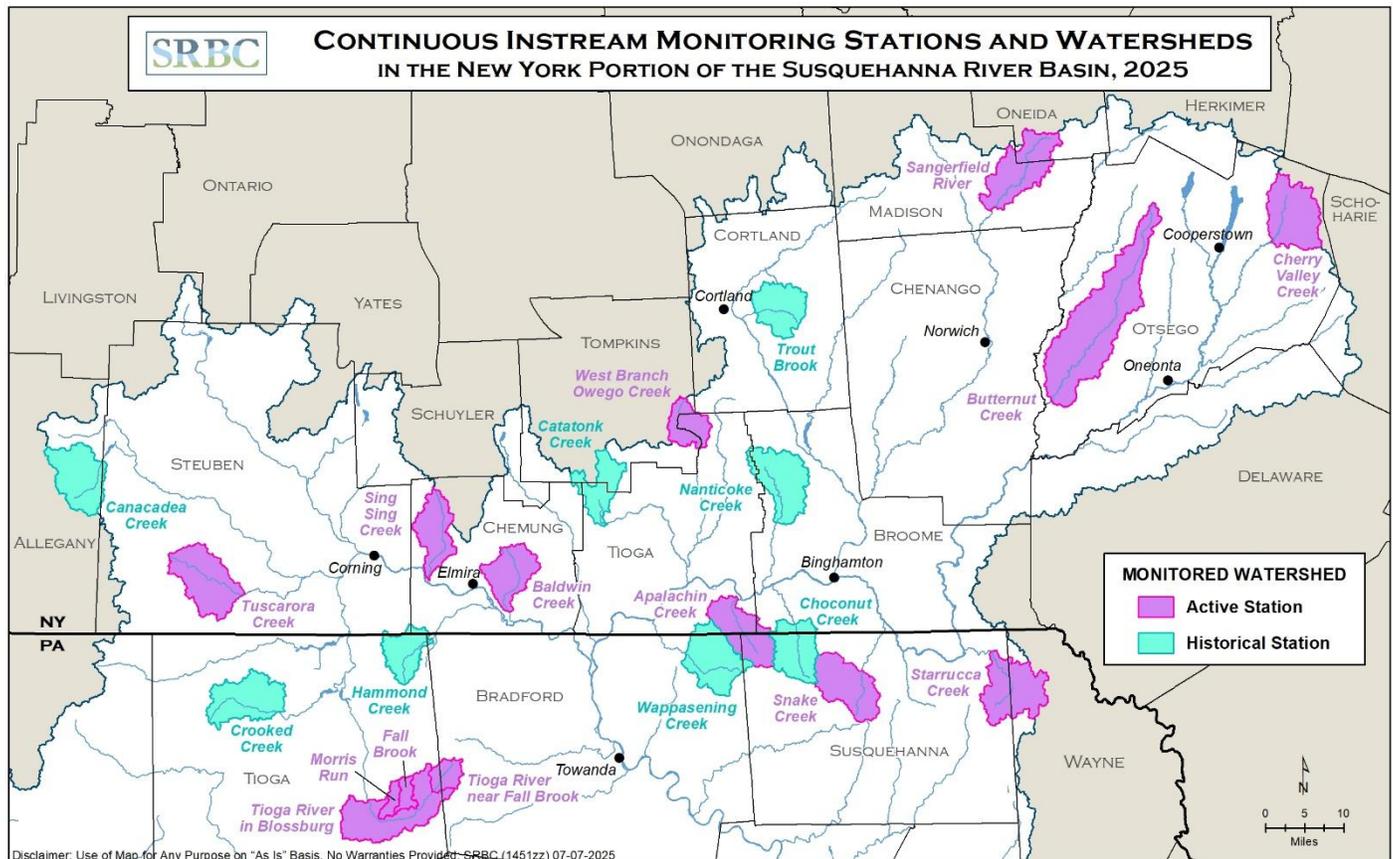
### Location of Upper and Chemung Subbasin CIM sites and watersheds: historic (teal) and active (purple) (2010-2025)

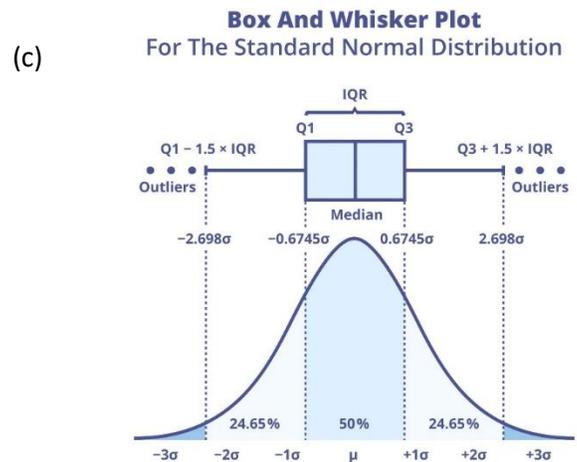
Sometimes the **median value (Q2)** falls above or below the middle of the box. When the median is closer to the minimum values, the boxplot has a **positive skew**, meaning most values are higher than the median. When the median is closer to the maximum value, the boxplot has a **negative skew (b)** meaning most values are lower than the median. When a value falls more than 1.5x the value of the IQR (or Q3-Q1), it is considered an **outlier**, and is represented by a dot above or below the minimum or maximum values **(c)**.

Possible boxplot distributions (b) and boxplot explanation in respect to the standard normal distribution (c). Images from <https://www.simplypsychology.org/boxplots.html>

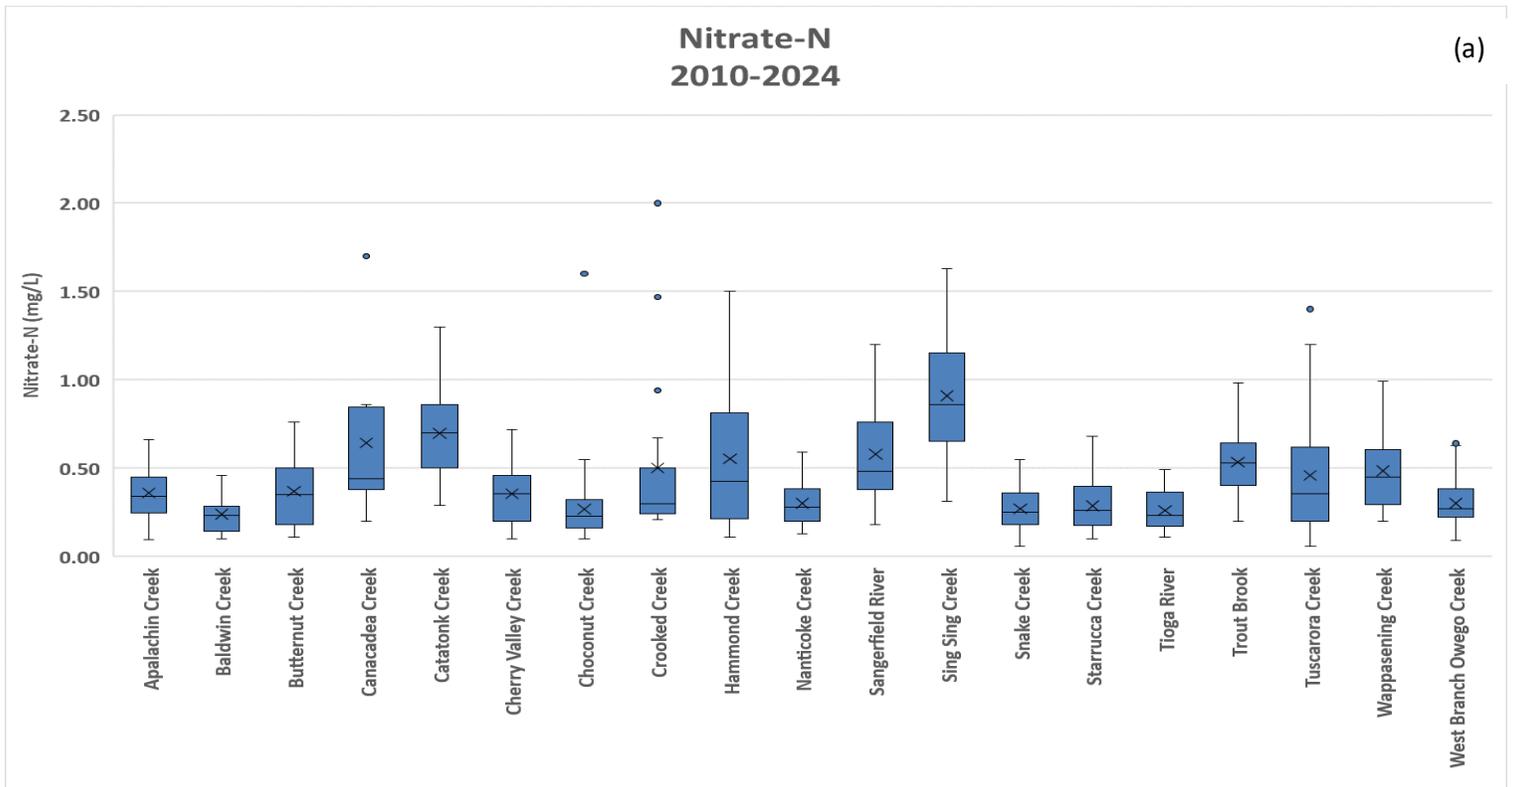
Boxplots for all sites for **NO<sub>3</sub>-N data (a)** and **TP data (b)** are presented below. An outlier in the nitrate-N dataset was removed (Sangerfield River, 4.60 mg/L), and two outliers from the phosphorus dataset were removed (Baldwin Creek, 0.71 mg/L and Butternut Creek, 4.40 mg/L) to better visualize results at a smaller scale.

Using our **nitrate data** (below), you can see examples of differently skewed boxplots. **Apalachin Creek (left)** has a relatively even distribution for nitrate values, whereas **Canacadea Creek (center)** has a positive skew, and **Wappasening Creek (right)** has a slightly negative skew. In our boxplots, the X represents the mean, or average, value. The width of a boxplot reflects variability of the data. The wider a box, the more spread there is among the data points.
