Muddy Run Pumped Storage Project American Eel Collection Facility in Octoraro Creek, 2023

FERC Project No. 2355

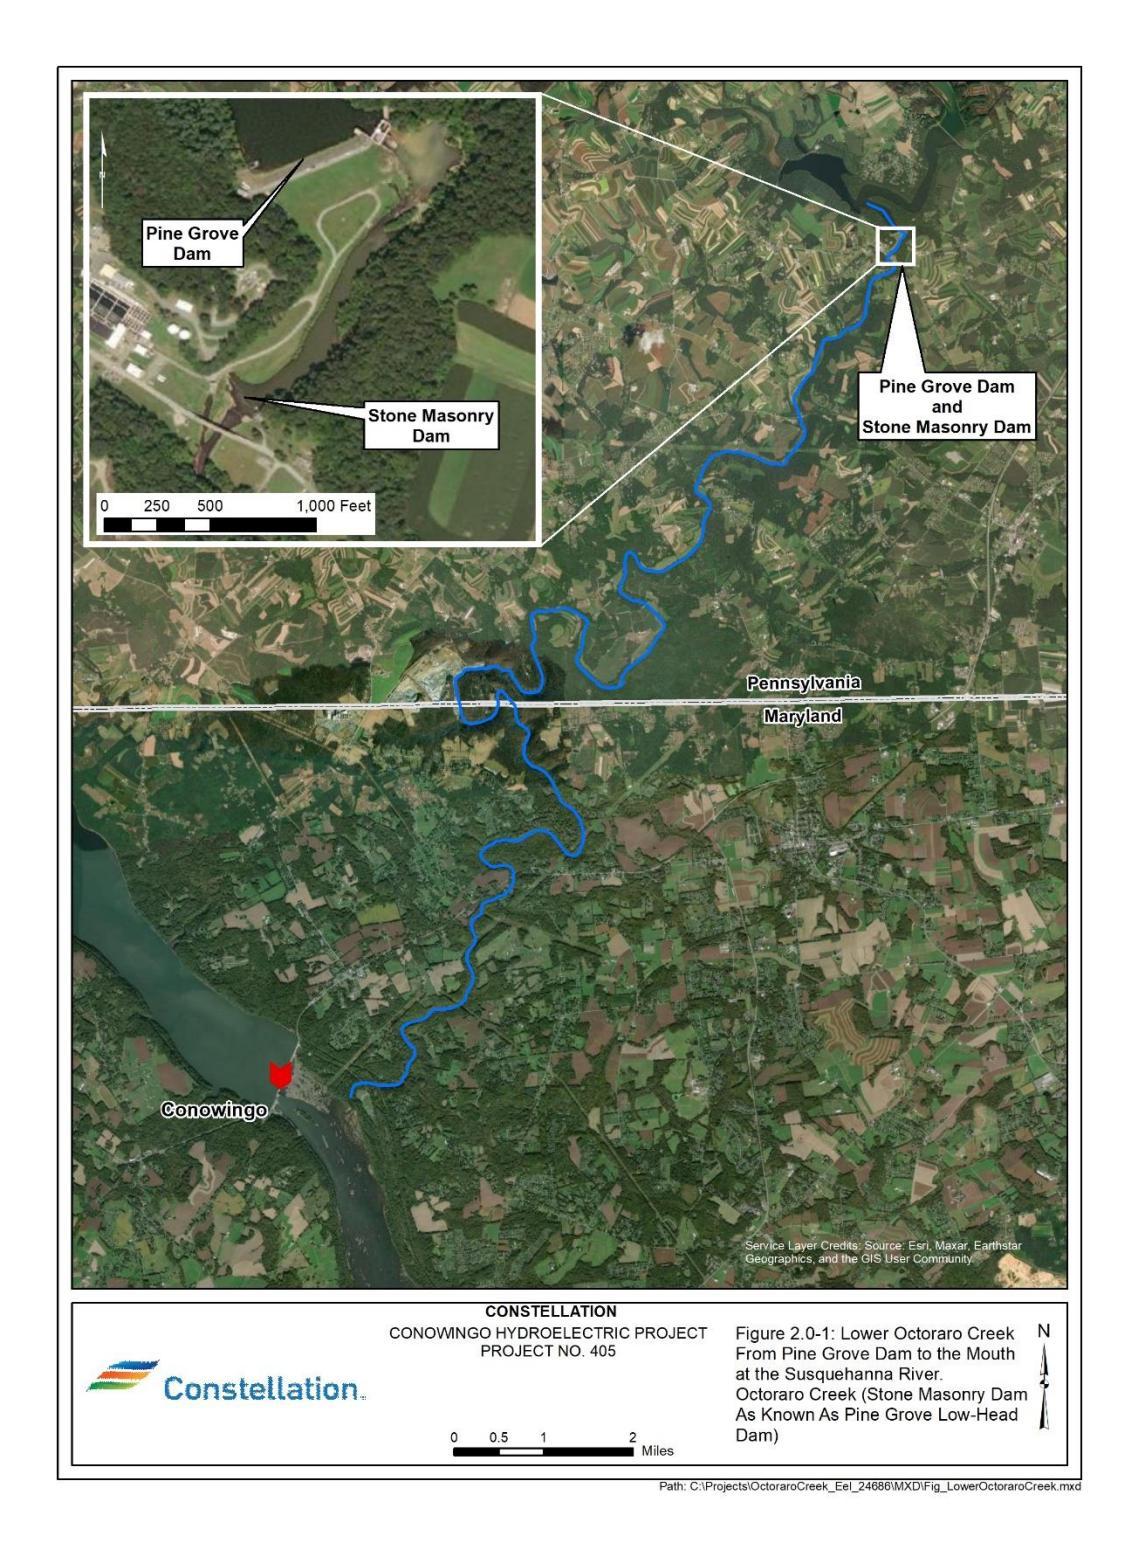
Figure 2.0-1: Lower Octoraro Creek from Pine Grove Dam to the Mouth at the Susquehanna River, Octoraro Creek (Stone Masonry Dam Also Known as Pine Grove Low-Head Dam)

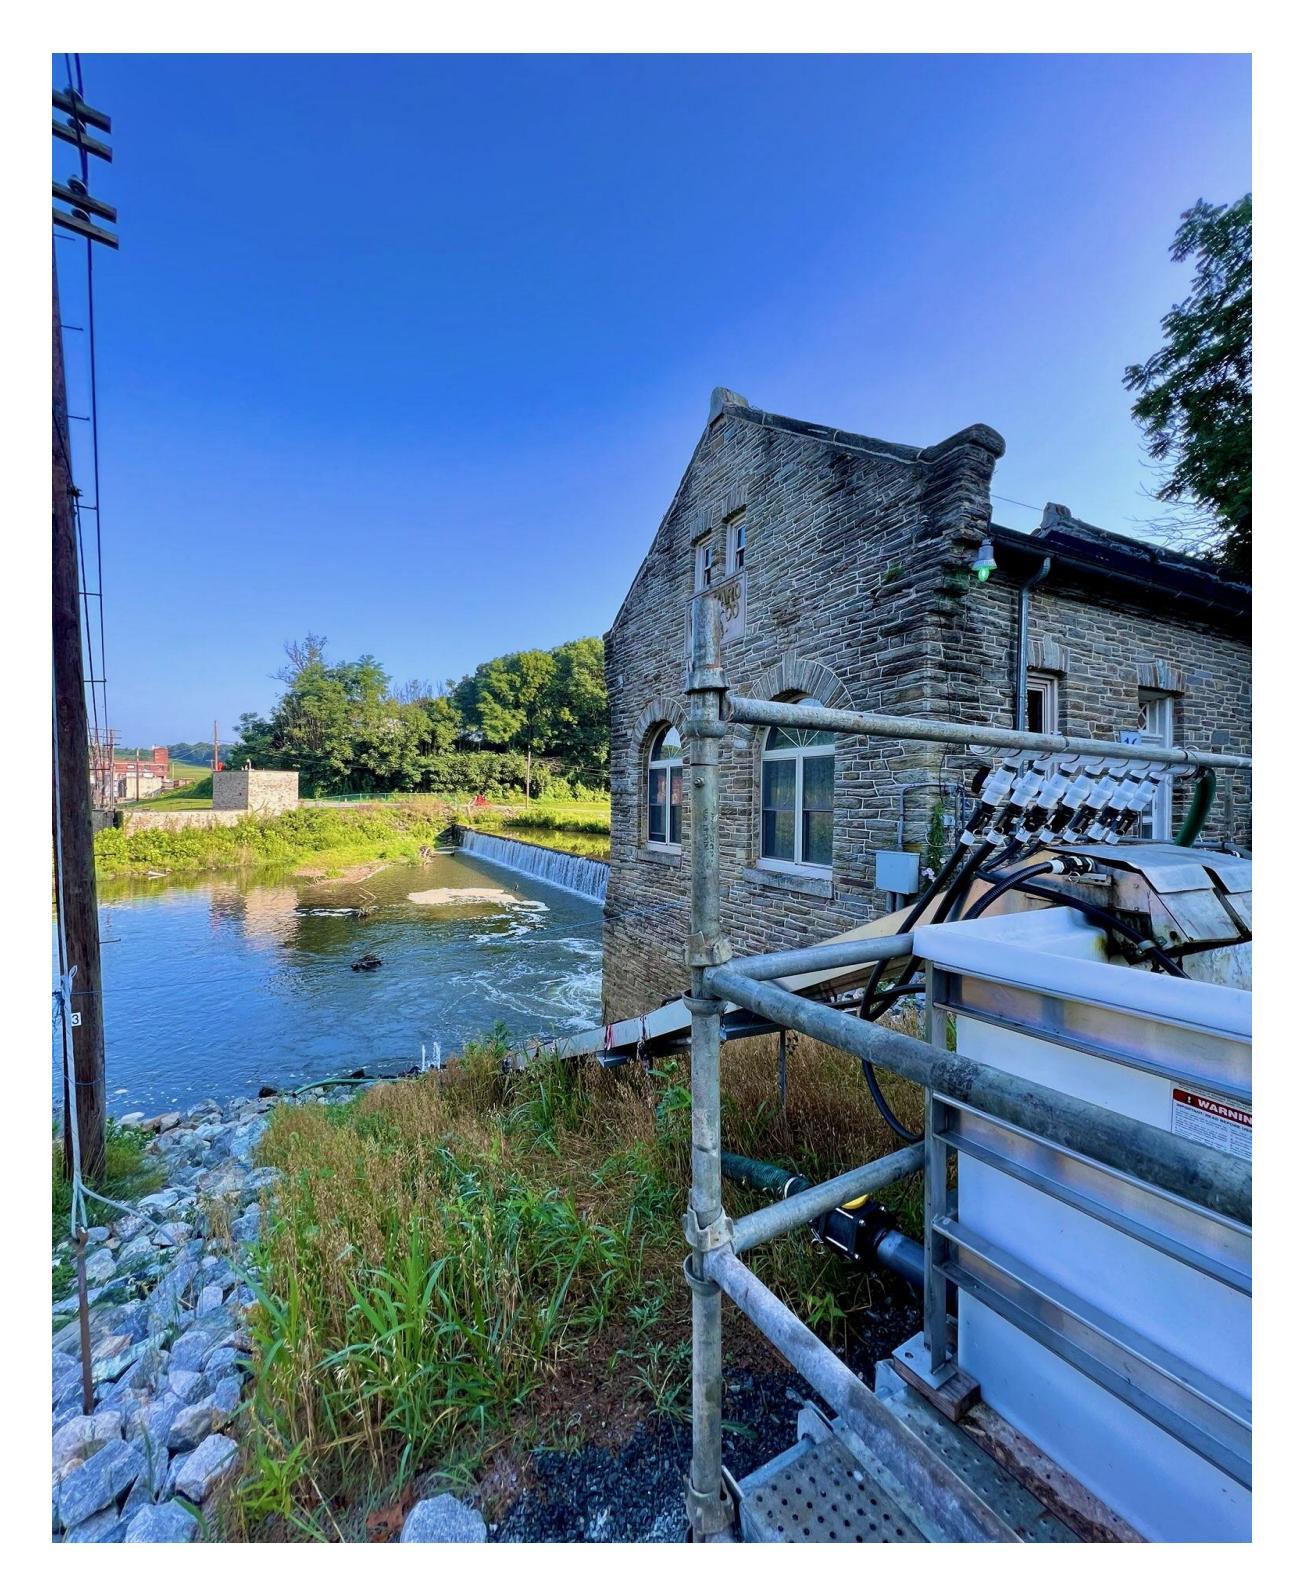
Figure 3.1-1: Overview of the Collection Tank with Support Frame and Scaffolding at top of the hill, Octoraro Creek Eel Facility, 2023

The size of the scaffolding platform was increased in 2022 to an eight foot by ten-foot platform to support the larger collection tank and oxygen supply system (Figure 3.1-1). A 1,061-liter collection tank replaced the former 310.4-liter tank, which increased the holding capacity of the tank from 3,104 eels to 10,610 eels. This larger tank was installed to minimize holding mortality of eels during periods of high capture rate. A stainless-steel frame was installed to support the collection tank. The manifold and submersible pump remained the same as the previous years (Normandeau Associates and Gomez and Sullivan 2020, 2021, and 2022). The rainfall gauge was reinstalled on the corner of the scaffolding to record daily rainfall events.

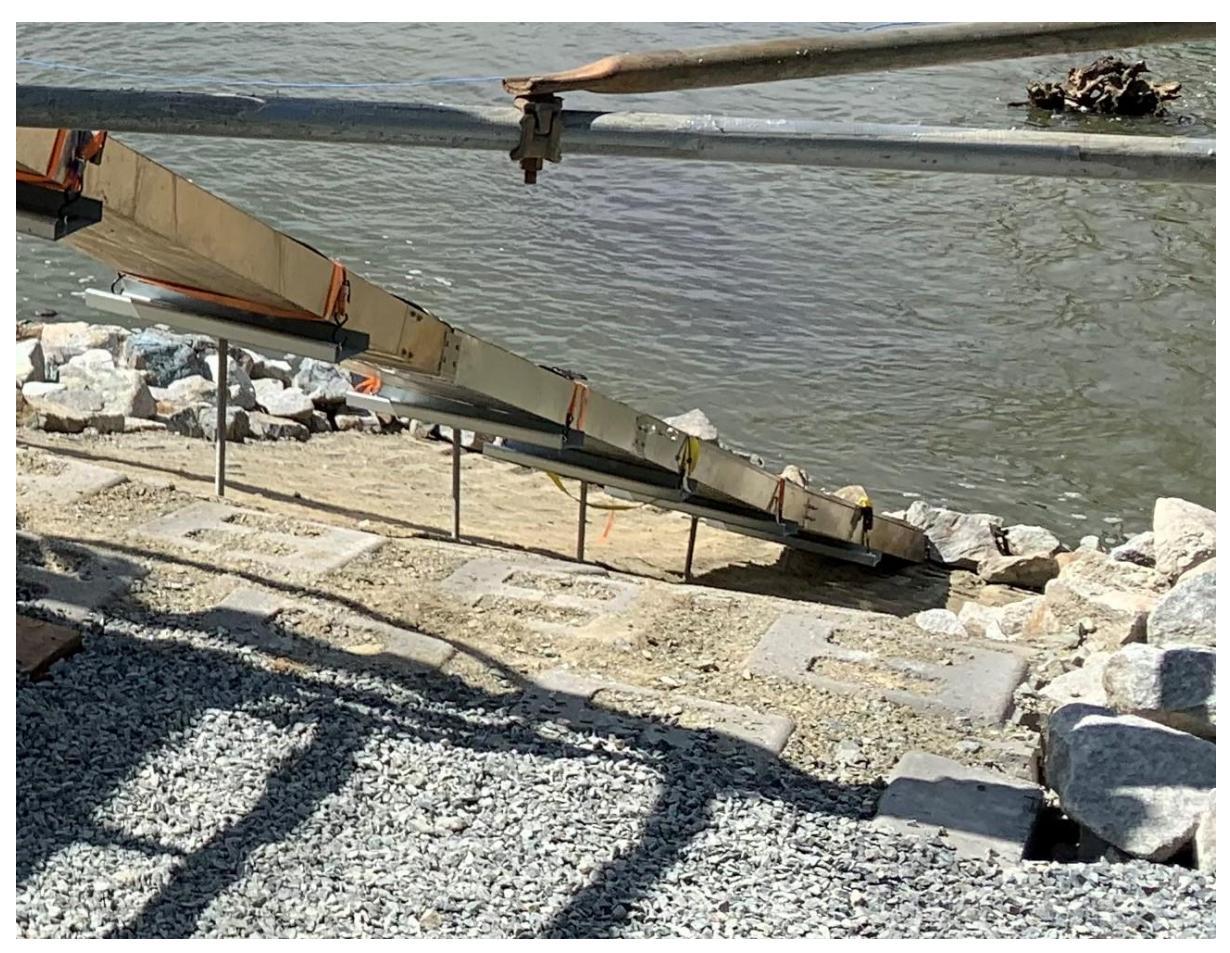
Figure 3.1-3: T-bar supports driven through ACBs, Octoraro Creek Eel Facility, 2023

bottom of the ramp was in contact with the creek bottom, which would increase the chances of damage to the ramp under high creek flows and create safety issues during set-up, tear-down, and weekly calibration of the facility. The Enkamat substrate extended below the entrance of the ramp and between the riprap and the ACBs into the tailrace at all creek flows in 2023 (Figures 3.1-2 and 5.0-1).

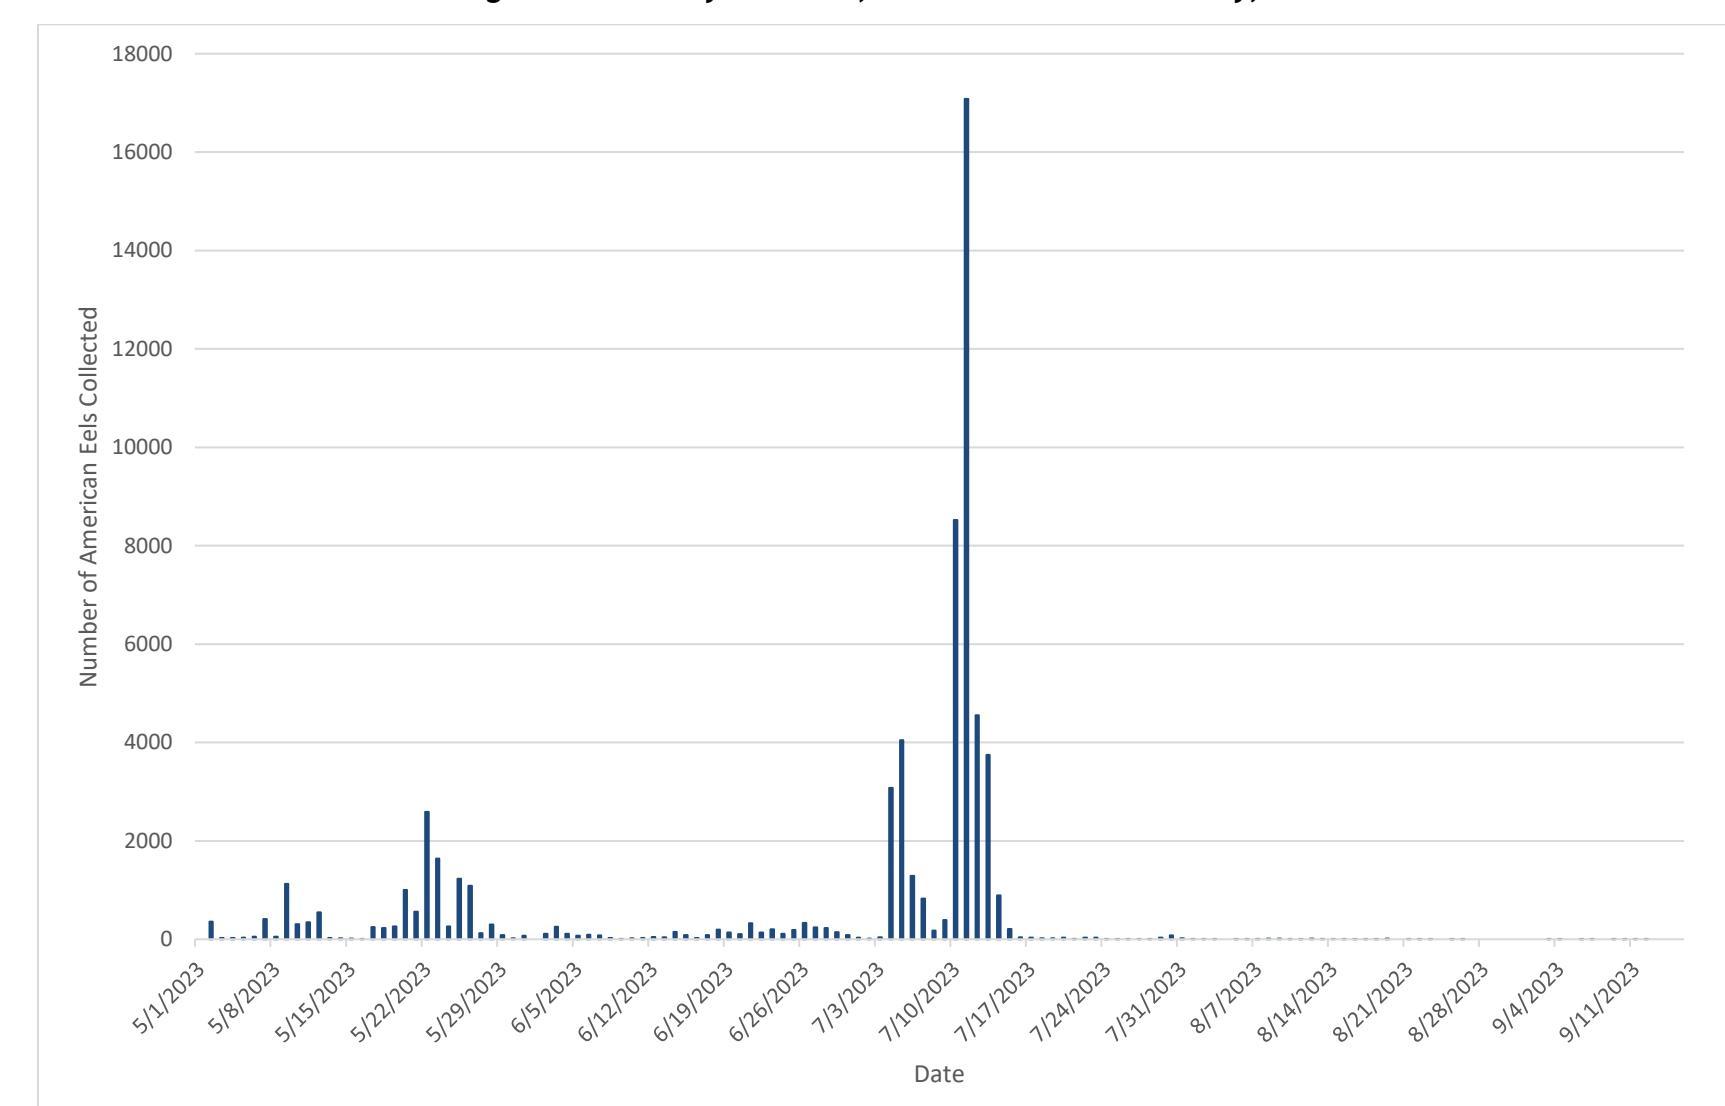
Figure 4.1-1: Daily Eel Catch, Octoraro Creek Eel Facility, 2023

The OCEF commenced operation on May 1, and operation ceased on September 15, 2023. The OCEF was monitored daily during the 138-day season to ensure that it was attracting eels. A total of 62,113 juvenile eels were collected during the 2023 season (<u>Table 4.0-1</u>). Daily monitoring was conducted as a condition of the OCEF's permanent status.

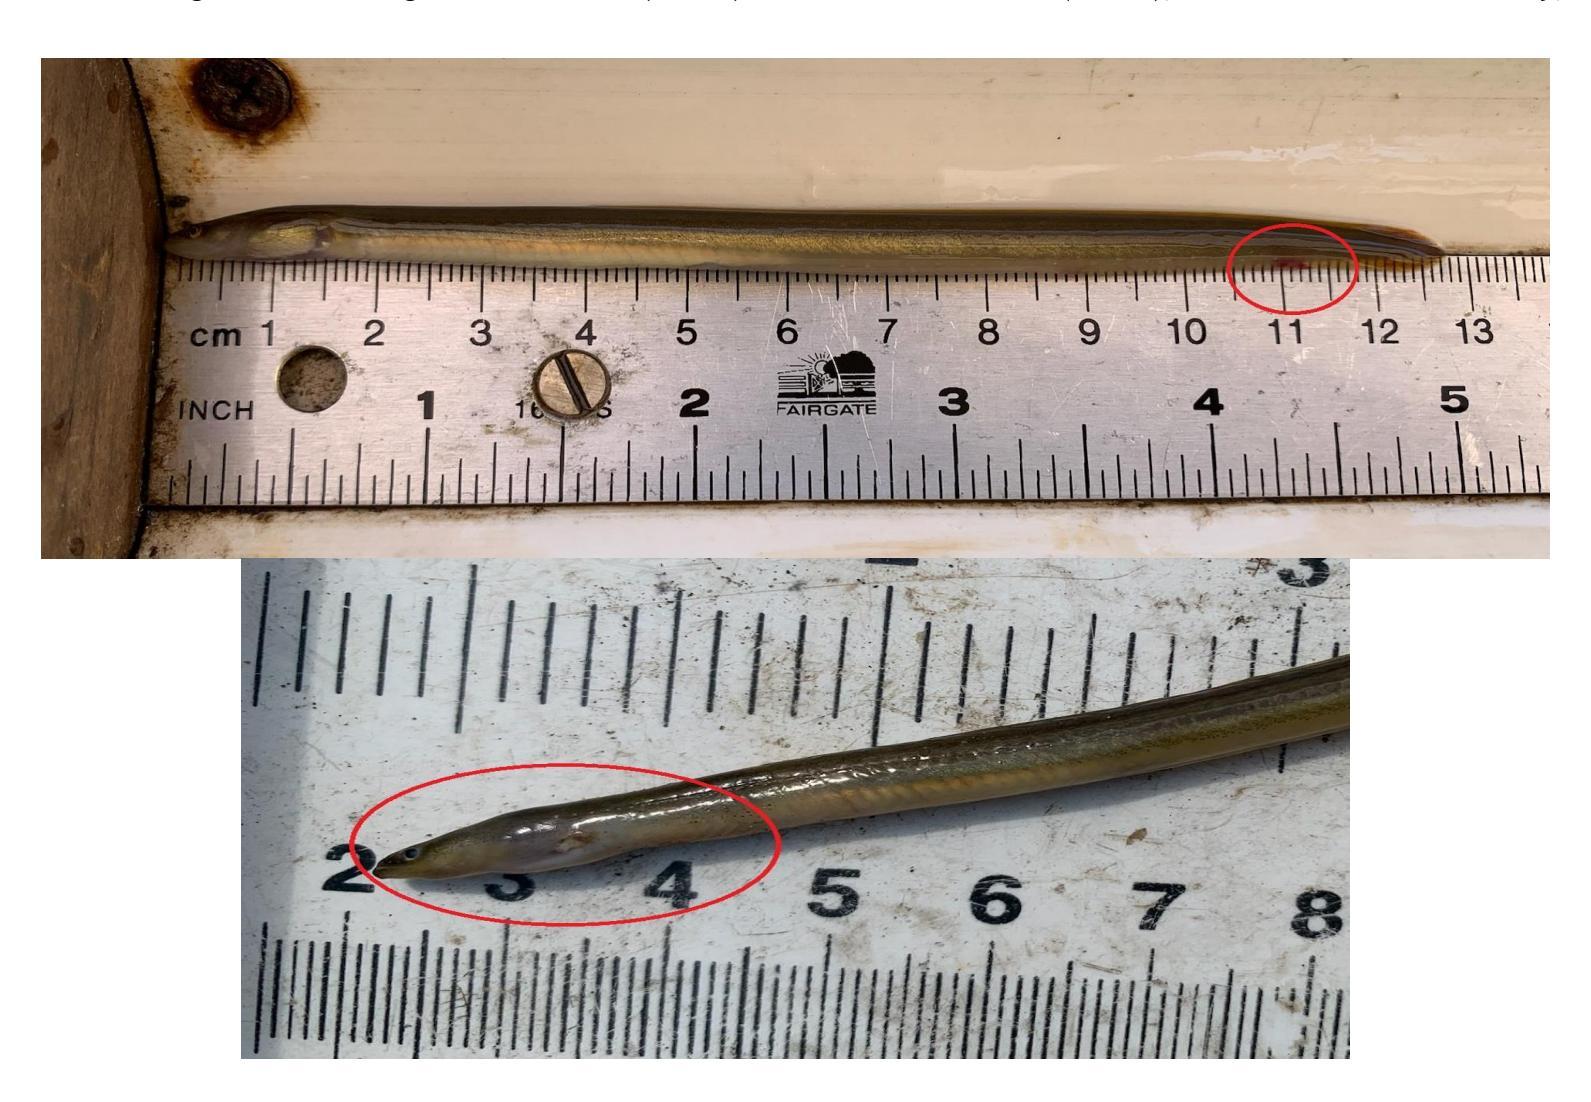
Figure 4.2-1: Image of Hemorrhage on Dorsal Tail (above) and Abrasion on Head (below), Octoraro Creek Eel Facility, 2023

Eels from each biweekly subsample were examined for external injuries. Individual condition factors, date, and detailed biological data for these are shown on <u>Table 4.2-4</u>. External injuries were noted on 0.5% (3 of 596 individuals) of the examined eels. A small hemorrhage on the dorsal tail was noted on an eel on May 7 and May 29, 2023, while an abrasion to the head area was observed on July 3, 2023 (<u>Figure 4.2-1</u>).

Date	Length (mm)	Weight (grams)	Condition Factor
05/07/2023	127	2.6	Slight Hemorrhage on Dorsal Tail
05/29/2023	136	2.6	Slight Hemorrhage on Dorsal Tail
07/03/2023	104	1.2	Abrasion on head

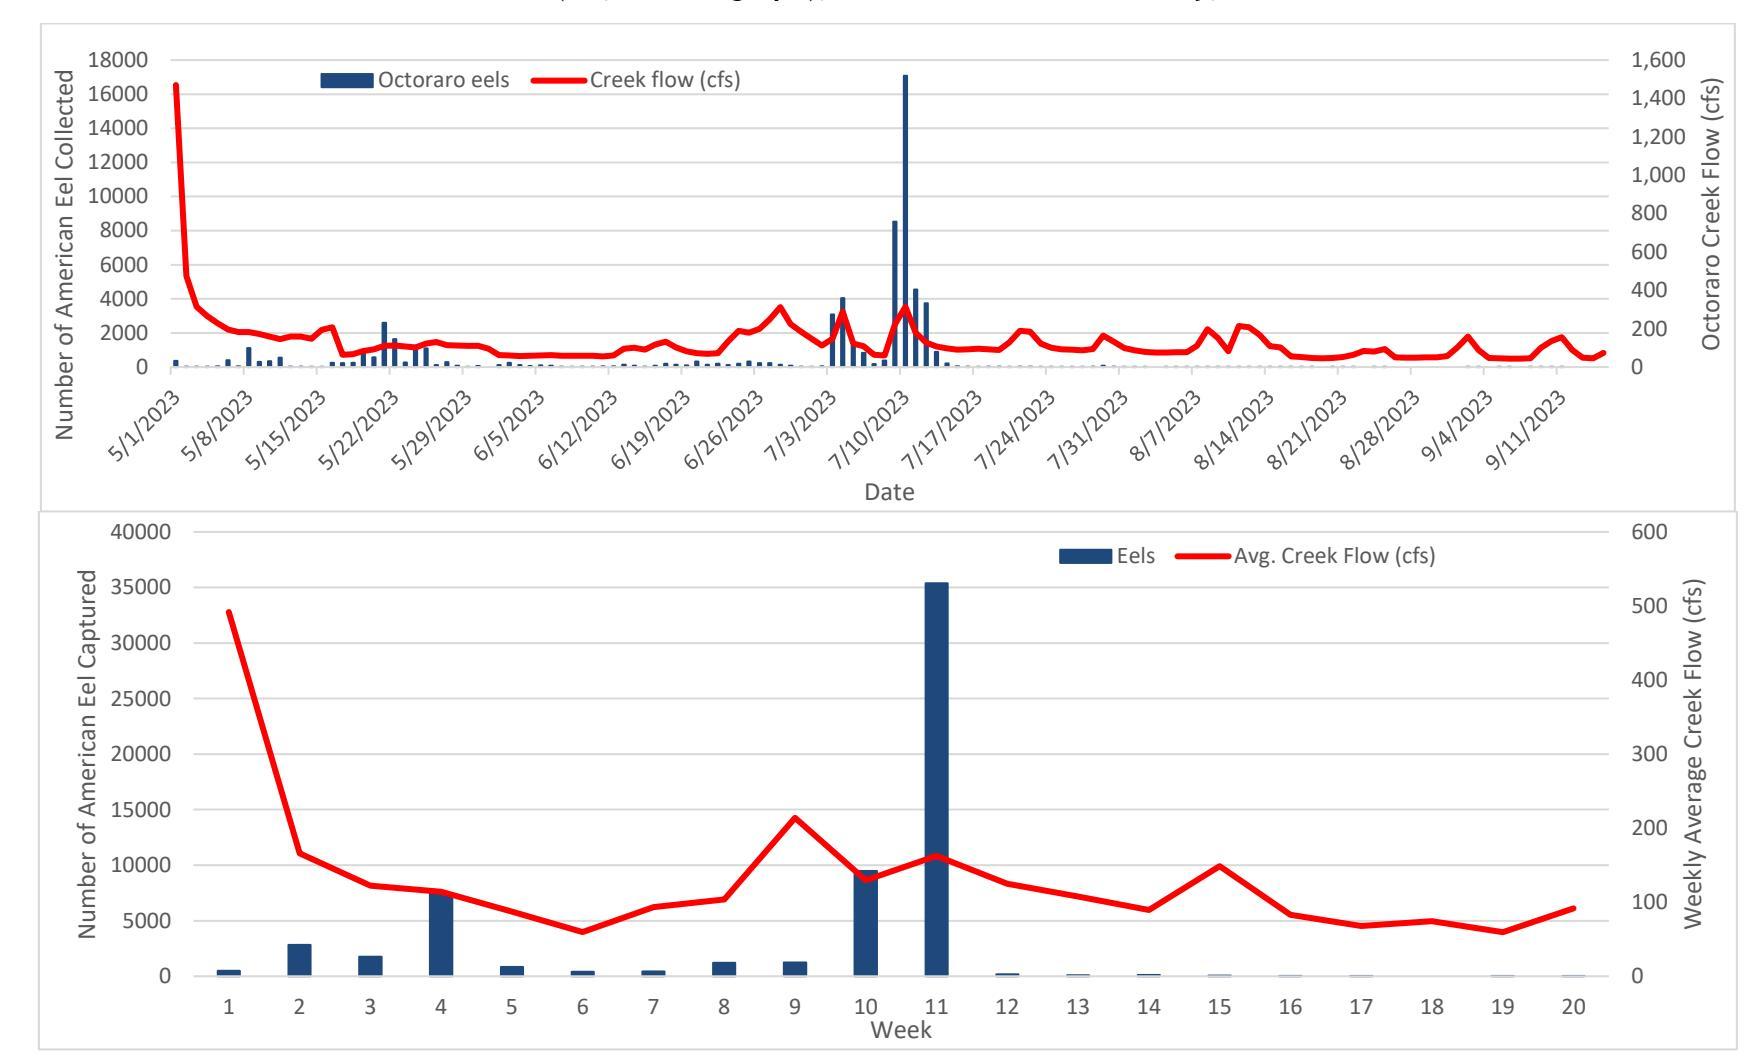
Figure 4.5-1: Daily Eel Catch and Daily Average Creek Flow (cfs, top graph) and Weekly Eel Catch and Weekly Average Creek Flow (cfs, bottom graph), Octoraro Creek Eel Facility, 2023

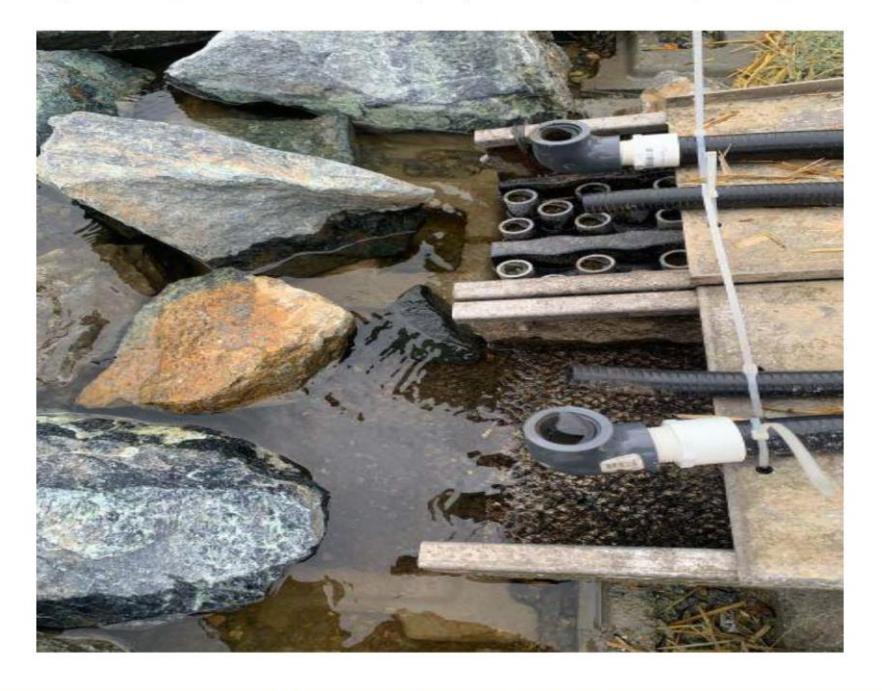
Figure 1. Image of Octoraro Creek Eel Facility Ramp Entrance at 182 Cubic Feet per Second, 2023

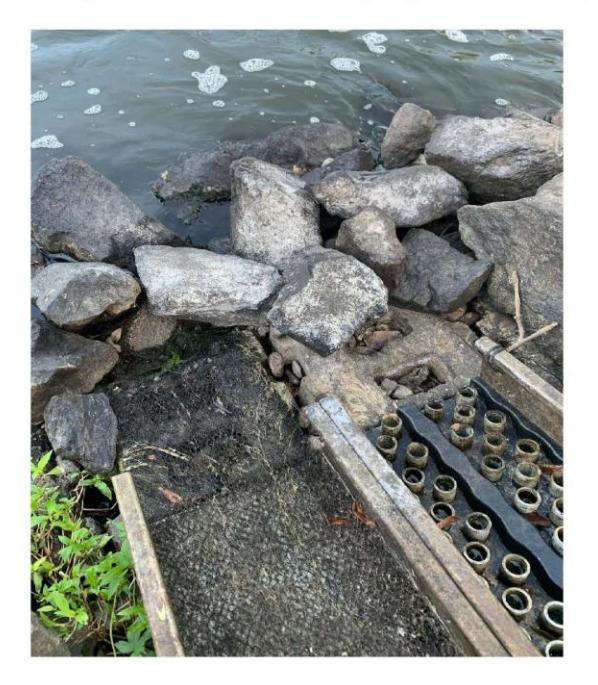
Figure 2. Image of the Octoraro Creek Eel Facility Ramp Entrance at 42.7 cfs, 2023

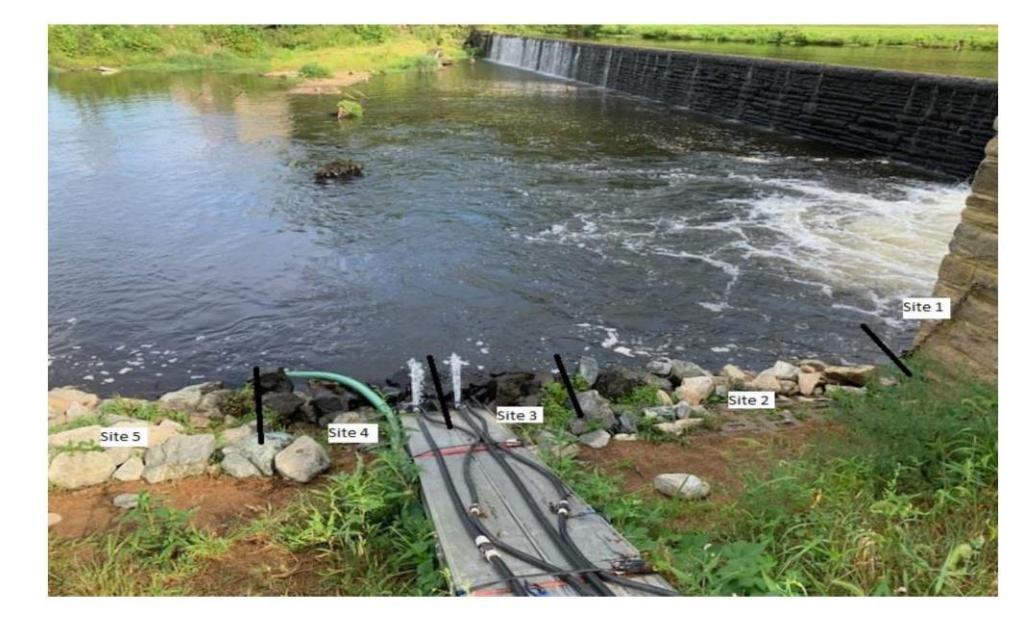
Figure 4. Individual sites within survey area (upstream section) at the Octoraro Creel eel facility ramp entrance during the red-light nighttime survey, 2023

The observation area for this survey is defined from the Art Building to the beach downstream of the entrance. The observation area was broken down into sites to help define where eels could possibly congregate (Figures 4 and 5).

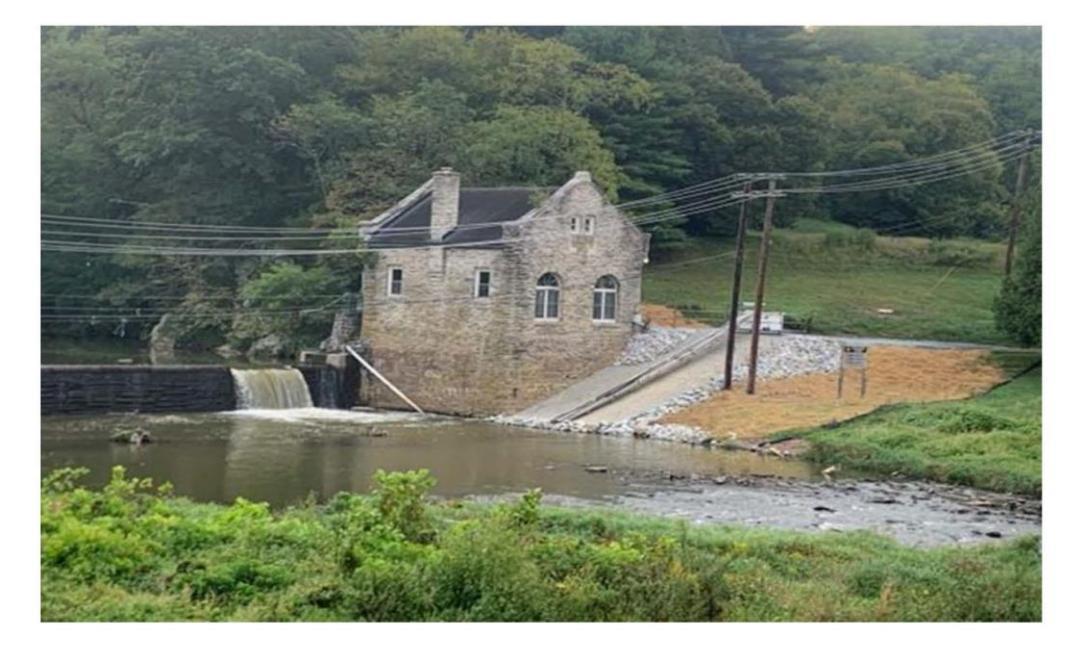
Figure 3. Overview of the Octoraro Creek Eel Facility After Protecting the Hillside from Erosion in 2022

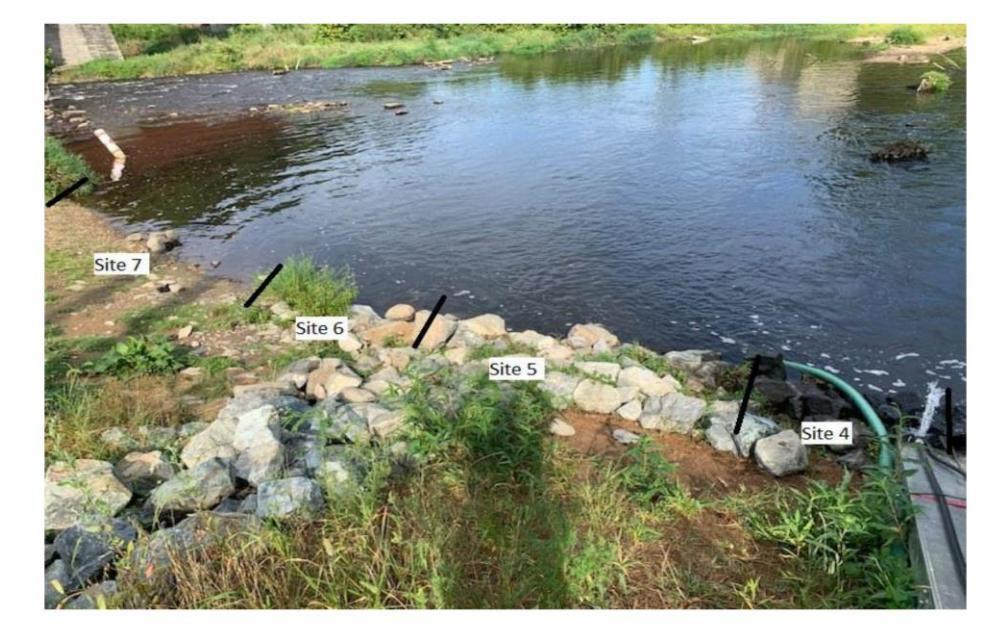
Figure 5. Individual sites within survey area (downstream section) at the Octoraro Creel eel facility ramp entrance during the red-light nighttime survey, 2023

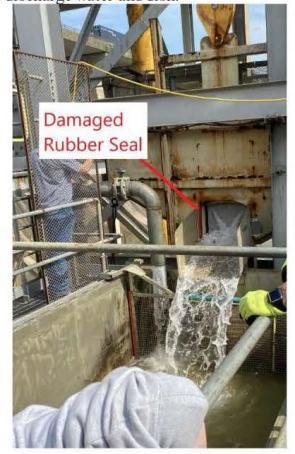
Damaged rubber seal between transfer sluice and sorting tank. Personnel from the
resource agencies noticed that the rubber seal that maintains a hydraulic connection
between the hopper and the transfer sluice (see photo below) was broken. As the
operators described it, the hopper is designed to slowly rise while it empties, and while
the fish are sluiced from the hopper into the sorting tank. The rubber seal should be
flexible enough to keep water, and fish, from falling through the growing space as the
hopper continues to discharge water and fish.

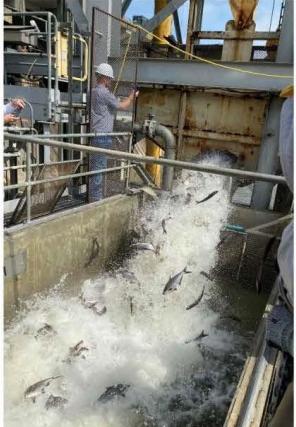
Little water cushion inside the sorting tank. The Service continues to be concerned about potential fish injuries from fish hitting the bottom, sidewall, and backwall of the sorting tank immediately after entering the tank through the high-velocity transfer sluice. The discharge of fish from the hopper and lack of initial water depth at the start of a fish transfer event from a hopper lift does not meet recommended fish passage guidance for plunging pools. Please consider maintaining a deeper water cushion inside the sorting tank before discharging the full volume of a hopper lift into it. If physical modifications are required to the tank to support a deeper initial receiving pool, one possible solution would be a double-walled sorting tank, where the inner wall would be shorter than the outer wall and have a porous grating on the top section to shed water into a channel that drains the excess water.

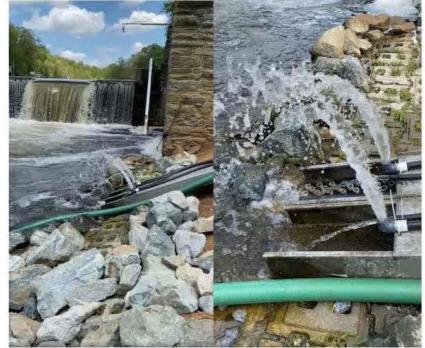
Nightly assessments at the entrances to the eel ramps: Please consider implementing nightly assessments to determine whether eels are finding the ramp entrances with ease, or if there is evidence that a portion of motivated eel migrants miss these entrances and end up at other locations in the adjacent wetted riprap. These observations should confirm if the entrances to the ramps are set in the best location possible, and if the extended substrate and corresponding attraction spray bars are meeting their intended purpose. Based on these observations, the relocation of the entrances, or the addition of another ramp could be considered, if deemed as potential improvements to eel collection at this location.
